New Premium CV Axles

Practical Solutions to Common CV Axle Problems

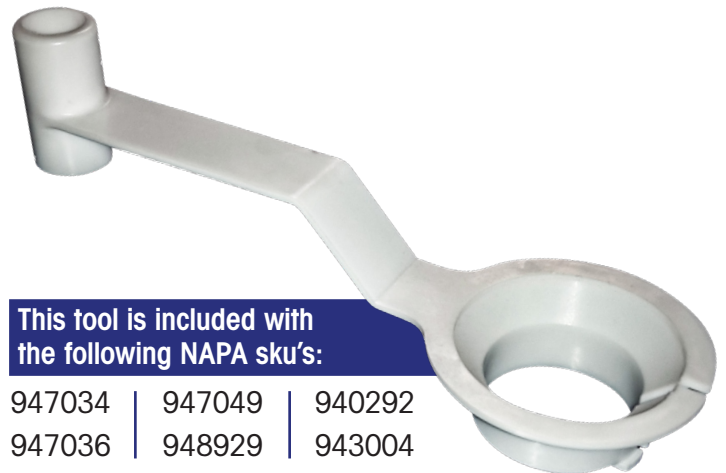
Problem: Some Ford and Mazda CV axles use a triangular clip to retain the axle. However, this clip is difficult to install without damaging the clip, the axle oil seal, or even the internal transmission gears. Applications using this clip design include:

- Ford - Escape and Contour
- Mazda - Tribute
- Mercury - Mariner, Mystique, and Cougar

Solution: NAPA now includes the correct alignment tool for these axle applications. This tool centers the clip for proper installation while also protecting the oil seal.

This tool is included with the following NAPA sku's:
