# NEW PREMIUM C.V. AXLE

## Practical Solutions to Common CV Axle Problems

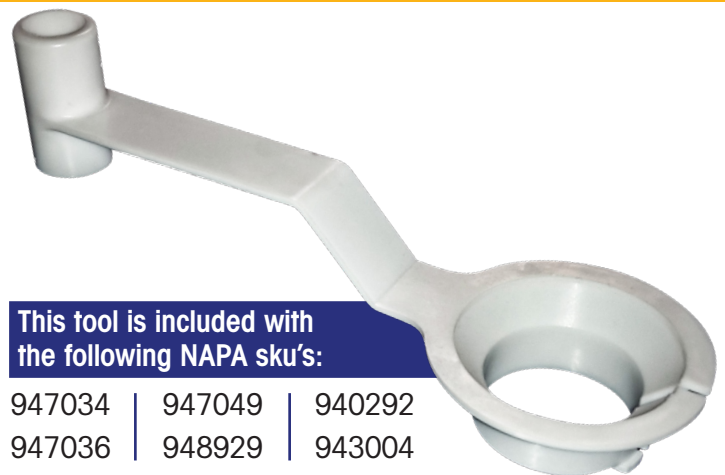
**Problem:** Some Ford and Mazda CV axles use a triangular clip to retain the axle. However, this clip is difficult to install without damaging the clip, the axle oil seal, or even the internal transmission gears. Applications using this clip design include:

**Solution:** NAPA now includes the correct alignment tool for these axle applications. This tool centers the clip for proper installation while also protecting the oil seal.

**This tool is included with the following NAPA sku's:**
