# NEW PREMIUM C.V. AXLE

## Tech Bulletin

### Top 5 Noise Symptoms of a Worn ATV-UTV CV Axle

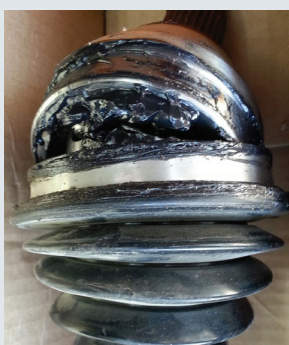
#### 1. Popping or clicking noises when turning.

This may be an indication of a worn or damaged outer CV joint. To verify this condition, place the vehicle in reverse, then crank the steering wheel or handlebars all the way to one side. Drive the vehicle backward in a circle. If the noise gets louder, it's time to replace the CV axle.

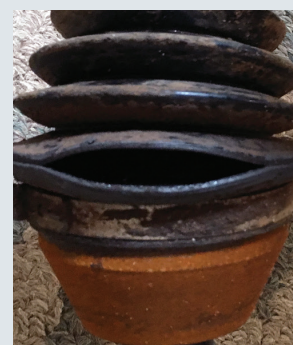
#### 3. A humming or growling noise.

This may be due to inadequate lubrication in either the inner or outer CV joint caused by a damaged or split boot. However, this symptom is more often due to worn or damaged wheel bearings, or worn shaft bearings.
