New Premium C.V. Axles

Practical Solutions to Common CV Axle Problems

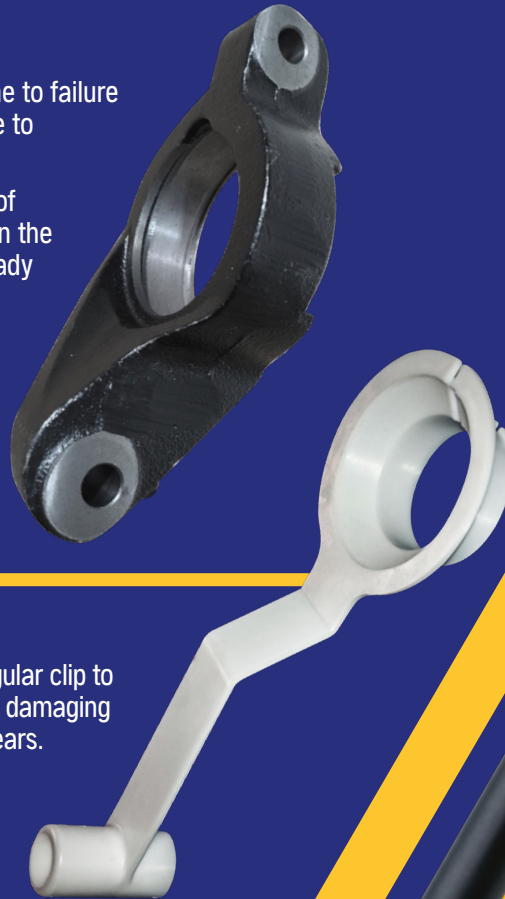
OEM AXLE BEARING BRACKETS

THE PROBLEM Some OEM axle bearing brackets are prone to failure because they are made of low-density aluminum and prone to breakage when being pressed onto a new axle bearing.

THE SOLUTION NAPA offers replacement brackets made of premium quality forged steel, which are much stronger than the OEM brackets. These brackets available separately or already installed on the correct NAPA replacement axle.

Bearing brackets are available for these common failure applications:

- 940086 - Mini Cooper 2007 - 2017
- 949721 - Toyota Highlander/Venza 2008-2017
- 949722 - Toyota Camry/Avalon 2012-2017
- 949723 - Toyota Sienna 2004-2010
