New Intermediate Shafts

DESIGNED TO IMPROVE VEHICLE HANDLING

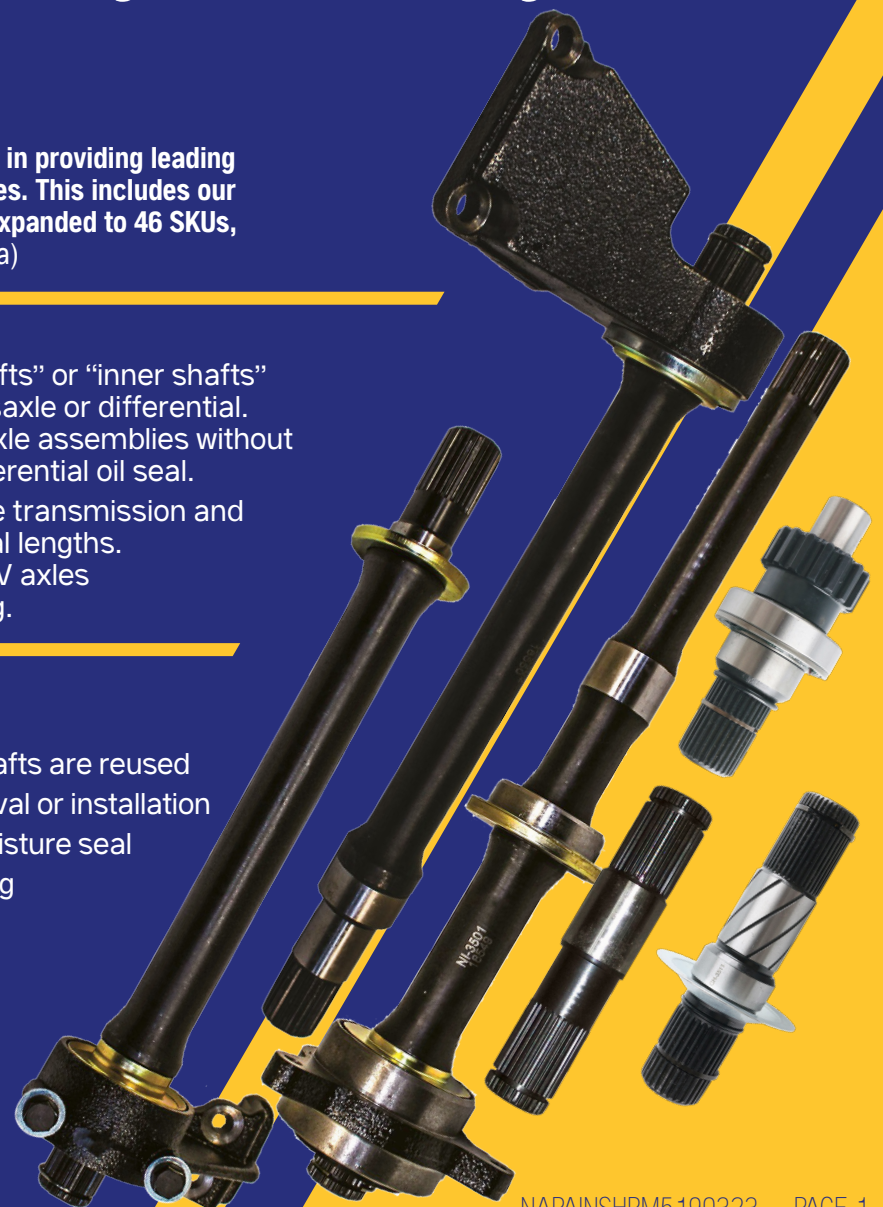
Intermediate shafts, often referred to as “stub shafts” or “inner shafts” act as the link that couples the CV axle to the transaxle or differential. They allow for the removal and installation of CV axle assemblies without the need to disturb or replace the transaxle or differential oil seal.

The intermediate shaft connects the CV axle to the transmission and ensures that the left and right CV axles are of equal lengths. The equal joint angles between the left and right CV axles reduce torque steer and improves vehicle handling.

- Intermediate shaft bearing failure
- Circlips not being replaced when intermediate shafts are reused
- Damage to splines or clips due to improper removal or installation
- Corrosion of the splines/clip due to failed dust/moisture seal

The above failures can lead to the CV axle becoming disengaged during operation causing loss of drive power and transaxle or differential damage.
