Ram Truck 1500 4WD Differential Housing Repair

Front Right, 2012-Up – Intermediate Shaft - Repair Kit 94-2592

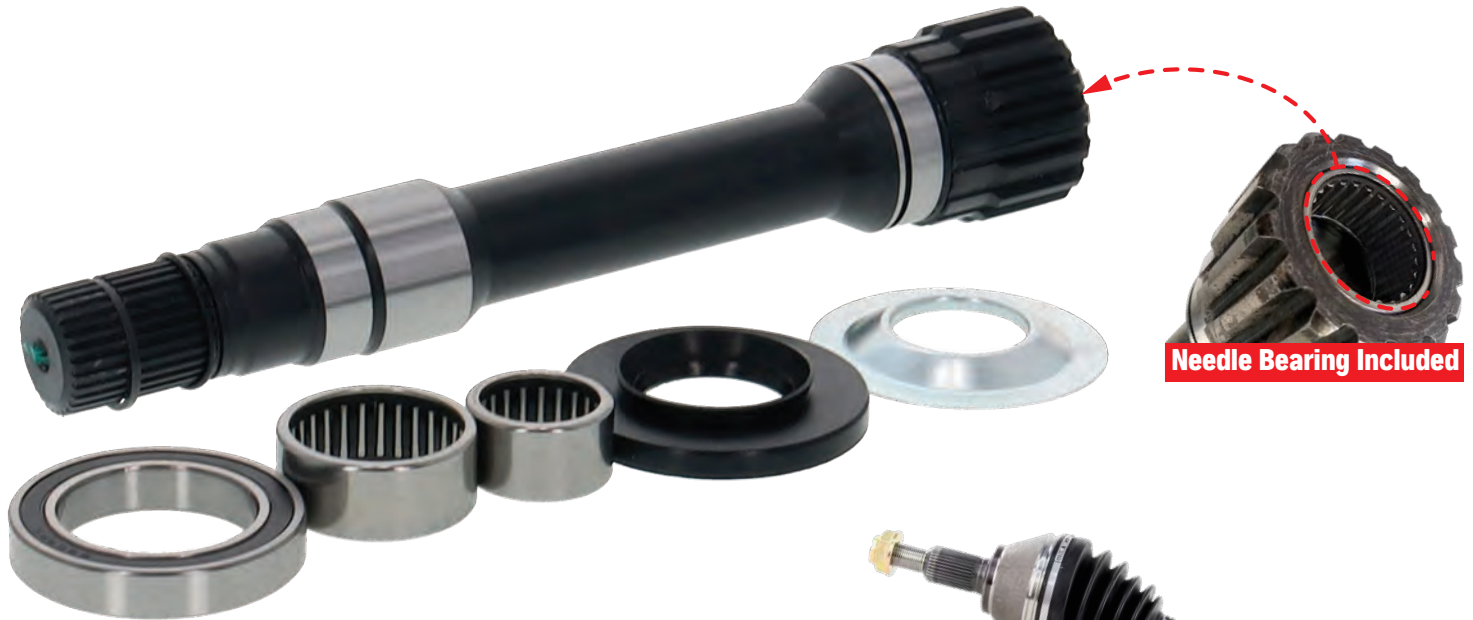
Needle Bearing Included

NAPA Kit 94-2592 (Rebuild Kit) includes all necessary parts, including a new intermediate shaft with all the components required to complete the repair, without having to spend thousands of dollars for a new differential.

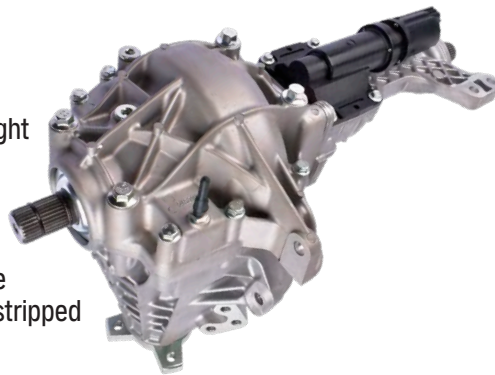
Clunking (or) vibration noises when trying to apply 4WD. The dashboard light indicates the Shift Actuator is working but it will not engage in 4WD.

The front right differential Intermediate Shaft to C.V. inboard joint splines are stripped which also causes a bearing failure.

The original connecting C.V. Shaft could also be defective if the intermediate shaft is damaged and should be replaced.

We strongly recommend replacing the C.V. Shaft with a new NAPA 94-9247, 94-1754 or 94-1737 when completing the job.
